## GERBER SOLARA UV2™ Firmware Version D

This document contains the release notes for this version of GERBER SOLARA UV2 firmware.

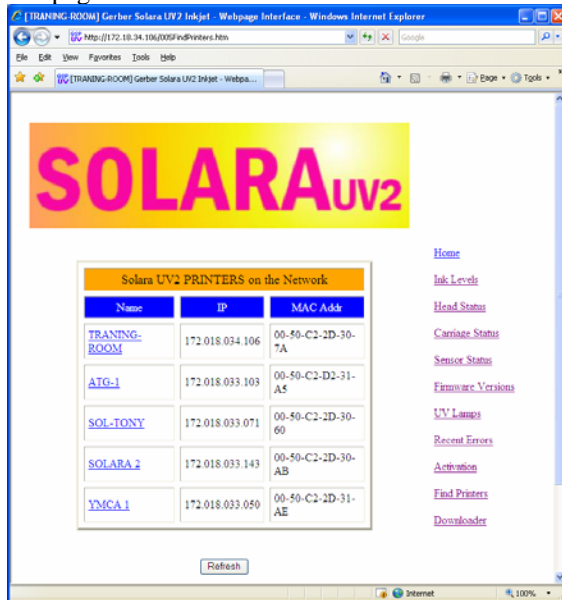
- The Ink Handling options in the SETUP menu (which include **Dry Load**, **Clear Line**, and **Purge**) have been moved to the Ink Service menu. From the Main Menu press Operate (F4), then Ink (F2), then Service (F3).
- The Find Printers webpage has been added to the Solara UV2 network interface. Users with more than one Solara on the same network can quickly navigate between printers by clicking on the printer name listed on the Find Printers page. By clicking on a printer's name, that printer's webpage is accessed.
